Niagara Region Wind Corporation  
Niagara Region Wind Farm

**Heritage Resources & Project Components  
Area 4**

Table 8: Evaluation of Cultural Heritage Resources and Landscapes, Area 4

Table 19: Summary of Potential Negative Impacts and Recommended Mitigation

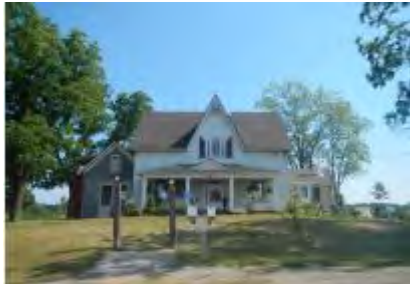
| Cultural Heritage Resource Number | Property | O.Reg. 9/06 Criteria | Justification | Rating | Thumbnail (full-size photos in Appendix A) |
|---|---|---|---|---|---|
| CHR-51 | 74221 Creek Road | Design or Physical | One and a half storey Gothic Revival cottage, central front porch with pediment and gable bargeboarding. Rare use of 2 over-4 lancet window with dual sidelights in area. | meets criteria | <p>Photo 69</p> |
| | | Historical or Associative | No known associations which satisfy criterion 2, O.Reg.9/06. | | |
| | | Contextual | Consistent with the character of the surrounding landscape. | | |

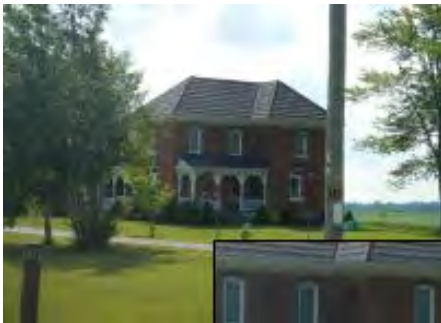
| Cultural Heritage Resource Number | Property | O.Reg. 9/06 Criteria | Justification | Rating | Thumbnail (full-size photos in Appendix A) |
|---|---|---|---|---|---|
| CHR-52 | 1187 Heaslip Road | Design or Physical | Two storey, irregular-shaped hipped roof brick farmhouse. Design features include: porches with bargeboard detailing; decorated frieze; bracketed eaves; and unique brickwork pattern detailing on front of house. Unique example of brickwork and bargeboard detailing on vernacular farmhouse in study area. | meets criteria | <p>Photo 70</p> |

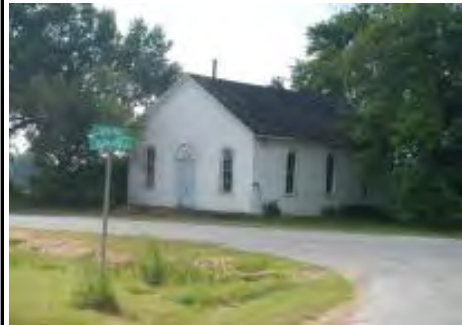
| Cultural Heritage Resource Number | Property | O.Reg. 9/06 Criteria | Justification | Rating | Thumbnail (full-size photos in Appendix A) |
|---|---|---|---|---|---|
| CHR-53 | Bethel Community Church | Design or Physical | One storey gabled-roofed church located at the intersection of Gee and Elcho Roads, established 1885. Design features include: three bay front façade; central double front doors with shaped transom; and 2-over-2 hung rounded wooden windows with paneled trim. Representative example of rural religious institution design in the area. | meets criteria | <p>Photo 71</p> |

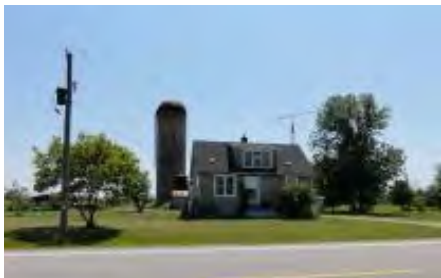
| Cultural Heritage Resource Number | Property | O.Reg. 9/06 Criteria | Justification | Rating | Thumbnail (full-size photos in Appendix A) |
|---|---|---|---|---|---|
| CHR-54 | 3974 Canborough Road | Design or Physical | One and a half storey gable-roofed cottage featuring three bay shed dormer, 1-over-1 windows and plaster siding. Rare use of plaster cladding in the study area. | meets criteria | <p>Photo 72</p> |
| | | Historical or Associative | No known associations which satisfy criterion 2, O.Reg.9/06. | | |
| | | Contextual | Does not contribute or maintain character of surrounding area in an integral way. Not physically, functionally, visually or historically linked to its surroundings in a demonstrable way. Not a landmark. | | |

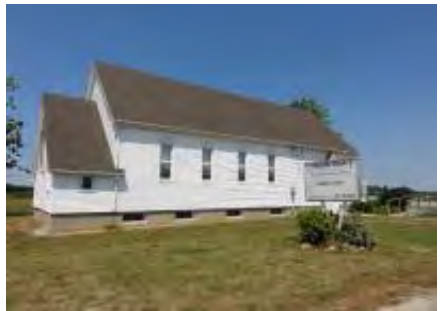
| Cultural Heritage Resource Number | Property | O.Reg. 9/06 Criteria | Justification | Rating | Thumbnail (full-size photos in Appendix A) |
|---|---|---|---|---|---|
| CHR-55 | Boyle Brethren in Christ Church | Design or Physical | Single storey gable-roofed church. Relocated to current position: originally the Zion Church, built 1899 in Pelham. Representative example of Pennsylvania Mennonite Meetinghouse architecture. | meets criteria | <p>Photo 73</p> |

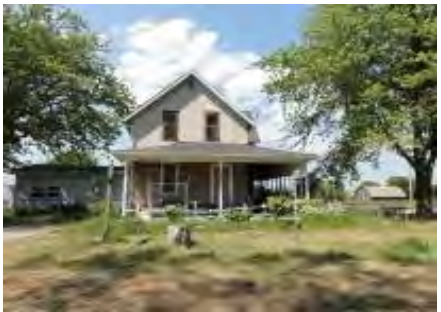
| Cultural Heritage Resource Number | Property | O.Reg. 9/06 Criteria | Justification | Rating | Thumbnail (full-size photos in Appendix A) |
|---|---|---|---|---|---|
| CHR-56 | 5205 Freure Road | Design or Physical | Two storey gabled-roofed farmhouse. Design features include two bay front façade, large wraparound porch and exterior plaster cladding. Rare use of plaster cladding in the area. | meets criteria | <p>Photo 74</p> |

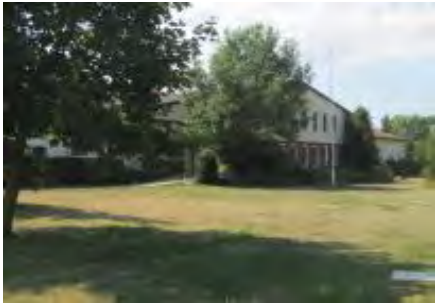
| Cultural Heritage Resource Number | Property | O.Reg. 9/06 Criteria | Justification | Rating | Thumbnail (full-size photos in Appendix A) |
|---|---|---|---|---|---|
| CHR-57 | 84004 Highway 4 | Design or Physical | Former Wellandport Christian School, closed in 2009. Established in 1958, it was affiliated with nearby Riverside Christian Reformed Church. Central two storey gable-roofed hall with one storey flanking wings with modern windows and cladding. Playground and sports fields to rear of property. | meets criteria | <p>Photo 75</p> |
| | | Historical or Associative | Associated with the development and education of local Christian community. | | |
| | | Contextual | Functions as a landmark. | | |

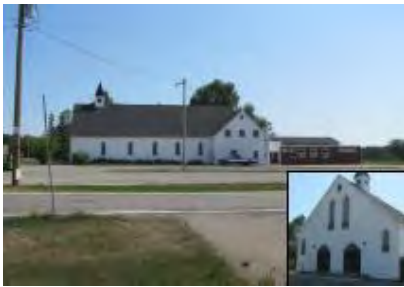
| Cultural Heritage Resource Number | Property | O.Reg. 9/06 Criteria | Justification | Rating | Thumbnail (full-size photos in Appendix A) |
|---|---|---|---|---|---|
| CHR-58 | Riverside Christian Reformed Church | Design or Physical | Established 1952, T-shaped church features belfry, five bay lancet windows along side elevation, and one storey rear extension. Church was affiliated with the former Wellandport Christian School, located nearby. | meets criteria | <p>Photo 76</p> |
| | | Historical or Associative | Associated with the settlement and development of Dutch Calvinists in the local community. | | |
| | | Contextual | Landmark | | |

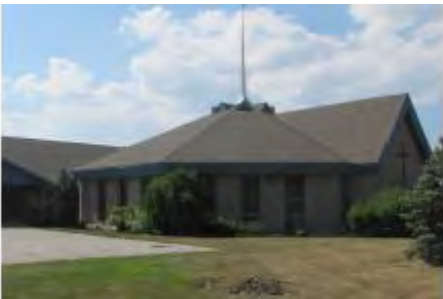
| Cultural Heritage Resource Number | Property | O.Reg. 9/06 Criteria | Justification | Rating | Thumbnail (full-size photos in Appendix A) |
|---|---|---|---|---|---|
| CHR-59 | Wellandport United Reform Church | Design or Physical | Modern brick church consisting of one storey hexagonal front hall with pyramidal roof, central spire and gabled front section, with one storey rear wing. | meets criteria | <p>Photo 77</p> |

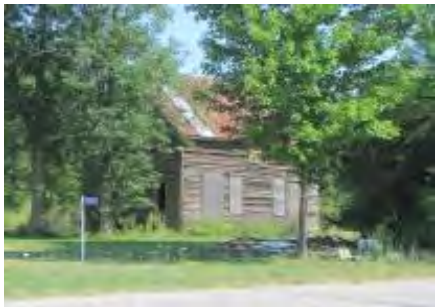
| Cultural Heritage Resource Number | Property | O.Reg. 9/06 Criteria | Justification | Rating | Thumbnail (full-size photos in Appendix A) |
|---|---|---|---|---|---|
| CHR-60 | 74015 Highway 4 | Design or Physical | One storey gabled-roofed structure, board and batten construction with wood cladding. Appears to be two boarded up front doors which suggest former use by Pennsylvania Mennonites. There is sufficient potential for it to possess design value to warrant its exclusion as a built heritage resource. | cannot be excluded | <p>Photo 78</p> |

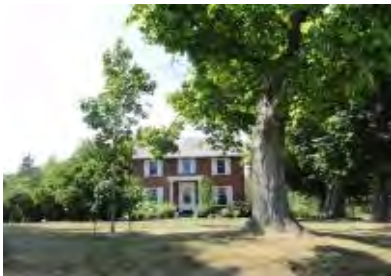
| Cultural Heritage Resource Number | Property | O.Reg. 9/06 Criteria | Justification | Rating | Thumbnail (full-size photos in Appendix A) |
|---|---|---|---|---|---|
| CHR-61 | 83610 Old River Road West | Design or Physical | Two storey gable-roofed brick house in the style of Colonial Revival. Three bay front facade featuring central front door with modest portico and 3-over-2 hung windows. Relatively rare and representative example of Colonial Revival design. | meets criteria | <p>Photo 79</p> |
| | | Historical or Associative | No known associations which satisfy criterion 2, O.Reg.9/06. | | |
| | | Contextual | Consistent with the character of the surrounding landscape. | | |

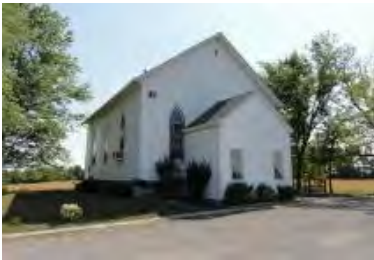
| Cultural Heritage Resource Number | Property | O.Reg. 9/06 Criteria | Justification | Rating | Thumbnail (full-size photos in Appendix A) |
|---|---|---|---|---|---|
| CHR-62 | Wellandport Church of Christ | Design or Physical | Modest one storey gable-roof church with extended, covered front entrance. Features chimney to rear of building, 3-over-2 hung lancet windows, and three bay side facades. May date to 19th century. | meets criteria | <p>Photo 80</p> |
| | | Historical or Associative | Associated with the development and religious education of the local community. | | |
| | | Contextual | Landmark | | |

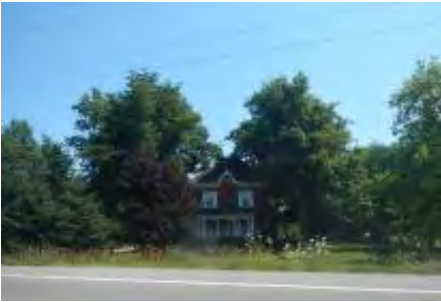
| Cultural Heritage Resource Number | Property | O.Reg. 9/06 Criteria | Justification | Rating | Thumbnail (full-size photos in Appendix A) |
|---|---|---|---|---|---|
| CHR-63 | 72587 River Road | Design or Physical | Two storey brick farmhouse. Design features include hipped roof with widow's walk, bracketed eaves, broken pediment surrounding round attic window, and central front porch with bargeboarding. Rare example of Italianate design in the area. | meets criteria | <p>Photo 81</p> |

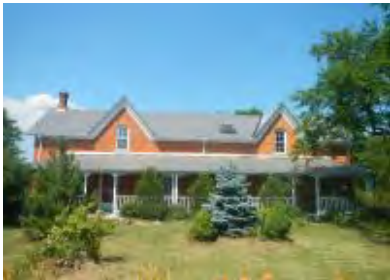
| Cultural Heritage Resource Number | Property | O.Reg. 9/06 Criteria | Justification | Rating | Thumbnail (full-size photos in Appendix A) |
|---|---|---|---|---|---|
| CHR-64 | 72170 River Road | Design or Physical | One and a half storey Gothic Revival style duplex with two front gables. Features 2-over-2 hung windows, and porch across front façade with bargeboarding. Rare example of double length house in the area. | meets criteria | <p>Photo 82</p> |
| | | Historical or Associative | No known associations which satisfy criterion 2, O.Reg.9/06. | | |
| | | Contextual | Consistent with the character of the surrounding landscape. | | |

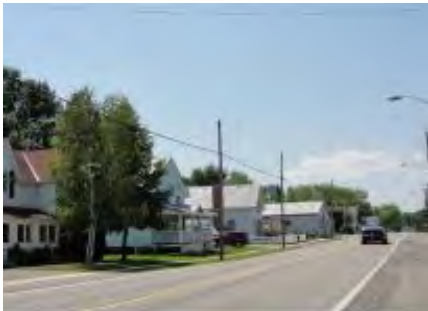
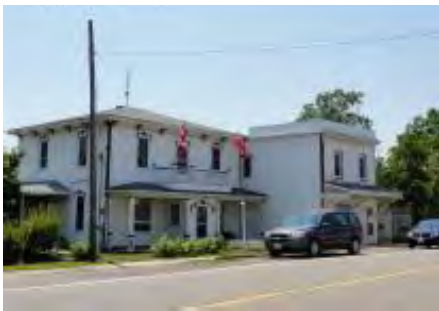
| Cultural Heritage Resource Number | Property | O.Reg. 9/06 Criteria | Justification | Rating | Thumbnail (full-size photos in Appendix A) |
|---|---|---|---|---|---|
| CHR-65 | Wellandport Streetscape | Design or Physical | The streetscape includes a number of buildings of individual design value on the north shore of the Welland River at the intersection of Canborough Road and Highway 27. The streetscape includes examples of mid-19th century commercial architecture, a mid-20th century community centre (Wellandport Community Centre), and a range of residential architectural styles ranging from modest one storey cottages to two storey Georgian, Victorian, and Edwardian Classicism-inspired houses. | meets criteria | <br><br><p>Photos 83-87</p> |

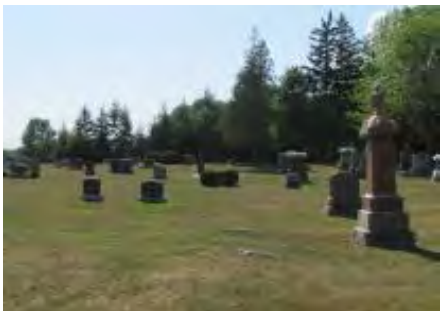
| Cultural Heritage Resource Number | Property | O.Reg. 9/06 Criteria | Justification | Rating | Thumbnail (full-size photos in Appendix A) |
|---|---|---|---|---|---|
| CHR-66 | Wellandport (Riverside) Cemetery | Design or Physical | Active cemetery dating back to late 18th century. Set on bank of Chippewa Creek (Welland River), landscape is characterized by gravemarkers set on a gently rolling terrain and bordered by a fence and line of mature trees. The site may also include the location of one of the first, log-constructed schools in Wellandport (Welland History, 2012). | meets criteria | <p>Photos 88 and 89</p> |

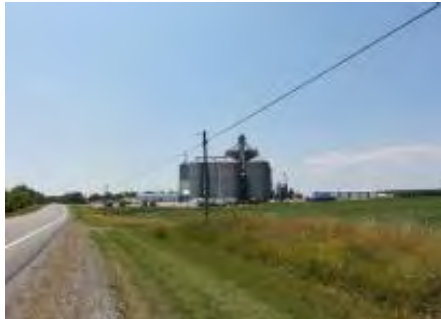
| Cultural Heritage Resource Number | Property | O.Reg. 9/06 Criteria | Justification | Rating | Thumbnail (full-size photos in Appendix A) |
|---|---|---|---|---|---|
| CHR-67 | 4891 Canborough Road | Design or Physical | Clark Agricultural Services. A modern agricultural complex with several large steel silos constructed for the storage and distribution of grain, fertilizer and other agricultural products. Not a rare, unique, early or representative example of a particular style, use of materials or method of construction. Does not demonstrate an unusually high degree of craftsmanship, artistic merit or scientific achievement. | meets criteria | <p>Photo 90</p> |

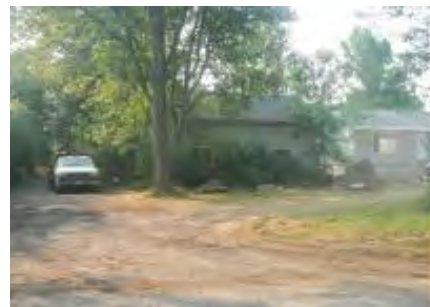
| Cultural Heritage Resource Number | Property | O.Reg. 9/06 Criteria | Justification | Rating | Thumbnail (full-size photos in Appendix A) |
|---|---|---|---|---|---|
| CHR-68 | 663 Marshagan Road | Design or Physical | One storey gable-roofed cottage with wooden siding and original windows. Property includes wooden vertical board barn at rear of property and modern one-storey bungalow. An early example of simple cottage-style construction in area. | meets criteria | |

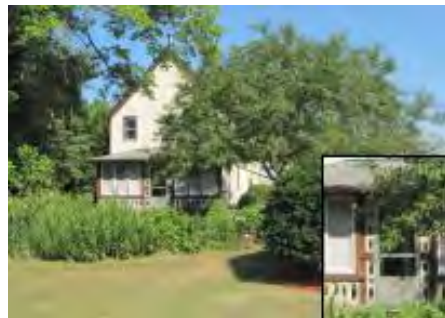
| Cultural Heritage Resource Number | Property | O.Reg. 9/06 Criteria | Justification | Rating | Thumbnail (full-size photos in Appendix A) |
|---|---|---|---|---|---|
| CHR-69 | 238 Gore A Road | Design or Physical | One and a half storey ell-shaped farmhouse, features enclosed front porch with wood framing and wine bottles set in plaster. Unique employment of wine bottle and plaster detailing. | meets criteria | |

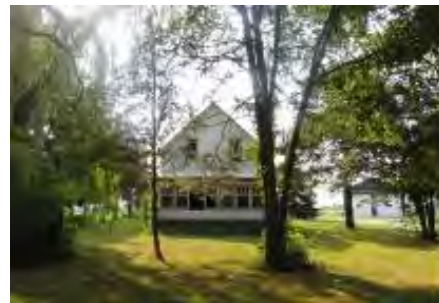
| Cultural Heritage Resource Number | Property | O.Reg. 9/06 Criteria | Justification | Rating | Thumbnail (full-size photos in Appendix A) |
|---|---|---|---|---|---|
| CHR-70 | 554 Hines Road | Design or Physical | One and a half storey vernacular farmhouse. Design features include enclosed front porch with 3-over-1 windows and plaster cladding. Rare use of plaster cladding in area. | meets criteria | |

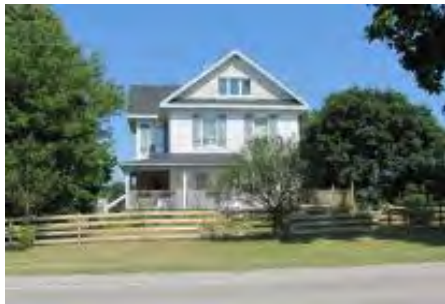
| Cultural Heritage Resource Number | Property | O.Reg. 9/06 Criteria | Justification | Rating | Thumbnail (full-size photos in Appendix A) |
|---|---|---|---|---|---|
| CHR-71 | 54051 Wellandport Road | Design or Physical | Two storey ell-shaped farmhouse. Design features include: wraparound porch; uniquely shingled gable pediment; and faux stone cladding. Unique use of gable and exterior cladding materials in area. | meets criteria | <p>Photo 94</p> |

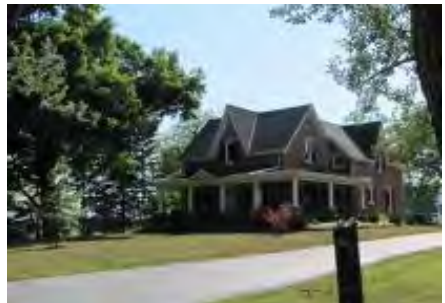
| Cultural Heritage Resource Number | Property | O.Reg. 9/06 Criteria | Justification | Rating | Thumbnail (full-size photos in Appendix A) |
|---|---|---|---|---|---|
| CHR-72 | 44088 Hendershot Road | Design or Physical | Two storey multiple-gabled brick farmhouse. Design features include large wraparound porch with pediment over doorway and columns set on stone pillars. Unique example in area of large, dominant porch on farmhouse. | meets criteria | <p>Photo 95</p> |

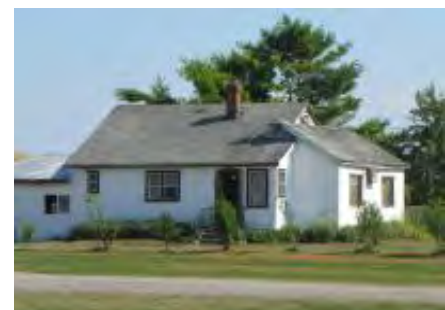
| Cultural Heritage Resource Number | Property | O.Reg. 9/06 Criteria | Justification | Rating | Thumbnail (full-size photos in Appendix A) |
|---|---|---|---|---|---|
| CHR-73 | 44067 Hendershot Road | Design or Physical | One storey gable-roofed cottage with additions. Features rare use of plaster cladding. | meets criteria | <p>Photo 96</p> |

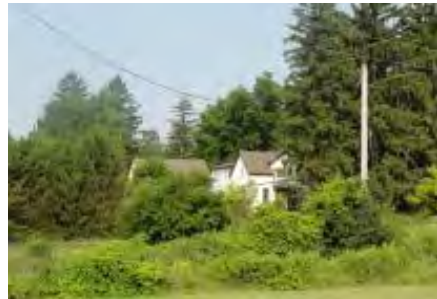
| Cultural Heritage Resource Number | Property | O.Reg. 9/06 Criteria | Justification | Rating | Thumbnail (full-size photos in Appendix A) |
|---|---|---|---|---|---|
| CHR-74 | 365 Jenny Jump Road | Design or Physical | One and a half storey vernacular residence with rear wing. Design features include 2-over-5 windows, and plaster cladding with half timbering detail. Rare example of plaster cladding. | meets criteria | <p>Photo 97</p> |
| | | Historical or Associative | No known associations which satisfy criterion 2, O.Reg.9/06. | | |
| | | Contextual | Consistent with the character of the surrounding landscape. | | |

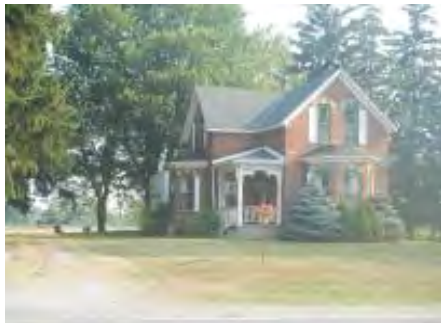
| Cultural Heritage Resource Number | Property | O.Reg. 9/06 Criteria | Justification | Rating | Thumbnail (full-size photos in Appendix A) |
|---|---|---|---|---|---|
| CHR-75 | 1943 Highway 3 | Design or Physical | Two storey, ell-shaped brick farmhouse with gabled roof. Design features include: dentils on bay windows and front porch, alternating pale and red brick voussoirs on windows, and bargeboard detailing on porch. Representative example of Edwardian Classicism-inspired vernacular, and rare example of dichromatic brickwork in general area. | meets criteria | <p>Photo 98</p> |

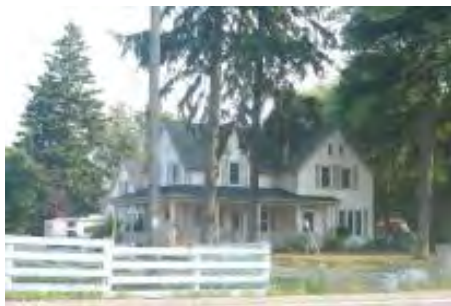
| Cultural Heritage Resource Number | Property | O.Reg. 9/06 Criteria | Justification | Rating | Thumbnail (full-size photos in Appendix A) |
|---|---|---|---|---|---|
| CHR-76 | 1855 Highway 3 | Design or Physical | Two storey multiple-gabled farmhouse. Design features include: wraparound porch; 2-over-2 hung windows; and pair of small, narrow windows in attic gables. Rare example of small attic windows which may suggest a Pennsylvania German design. | meets criteria | <p>Photo 99</p> |

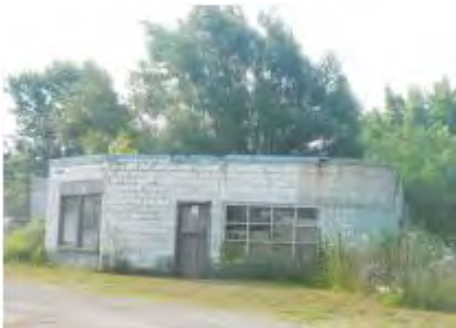
| Cultural Heritage Resource Number | Property | O.Reg. 9/06 Criteria | Justification | Rating | Thumbnail (full-size photos in Appendix A) |
|---|---|---|---|---|---|
| CHR-77 | 1668 Highway 3 | Design or Physical | One storey cinder block commercial or industrial building, features large 4-over-3 picture window. Appears to be a rare example of early- or mid-20th century garage. | meets criteria | <p>Photo 100</p> |

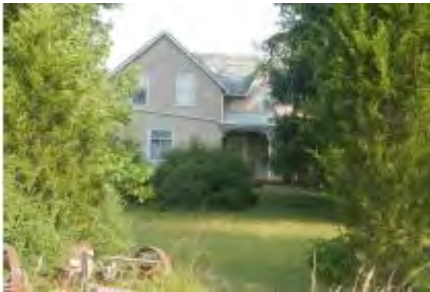
| Cultural Heritage Resource Number | Property | O.Reg. 9/06 Criteria | Justification | Rating | Thumbnail (full-size photos in Appendix A) |
|---|---|---|---|---|---|
| CHR-78 | 62 Booker Road | Design or Physical | Two storey ell-shaped Gothic Revival farmhouse and associated agricultural outbuildings. Design features include: stucco or plaster siding; minor bargeboard detailing on porch; and shaped window trim. Rare use of plaster exterior cladding. | meets criteria | <p>Photo 101</p> |
| | | Historical or Associative | No known associations which satisfy criterion 2, O.Reg.9/06. | | |
| | | Contextual | Consistent with the character of the surrounding landscape. | | |

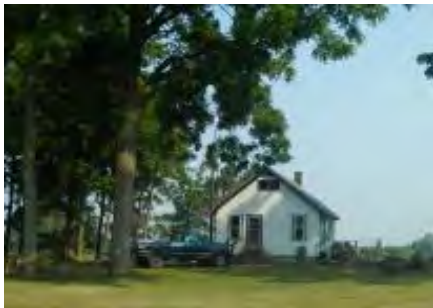
| Cultural Heritage Resource Number | Property | O.Reg. 9/06 Criteria | Justification | Rating | Thumbnail (full-size photos in Appendix A) |
|---|---|---|---|---|---|
| CHR-79 | 362 Booker Road | Design or Physical | One and a half storey gabled roof vernacular cottage. Design features include: plaster siding; offset front door; small attic window with triangular attic vent above. Rare use of plaster exterior cladding in the area. | meets criteria | <p>Photo 102</p> |

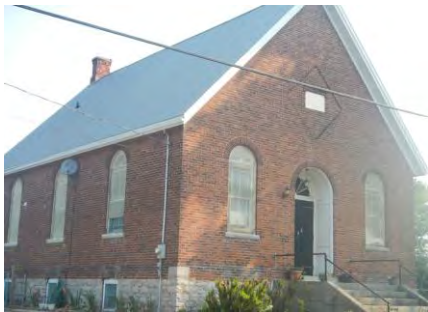
| Cultural Heritage Resource Number | Property | O.Reg. 9/06 Criteria | Justification | Rating | Thumbnail (full-size photos in Appendix A) |
|---|---|---|---|---|---|
| CHR-112 | 2083 Highway 3 | Design or Physical | The one and a half storey brick building is constructed on a rectangular plan, with a gabled roof. Design features include: a labelstone; multiple-paned hung windows with round brick headers and stone sills; and a brick chimney | meets criteria | <p>Photos 103 - 107</p> |

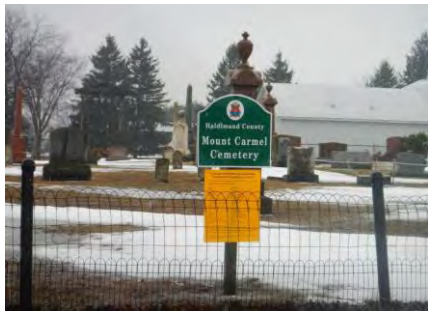
| Cultural Heritage Resource Number | Property | O.Reg. 9/06 Criteria | Justification | Rating | Thumbnail (full-size photos in Appendix A) |
|---|---|---|---|---|---|
| CHR-113 | 1300 Hutchinson Road | Design or Physical | The property consists of a small cemetery bordered by a wire fence with brick corner posts, gravemarkers dating to the late 19th century, and several large trees along Hutchinson Road | meets criteria | <p>Photos 108 - 114</p> |

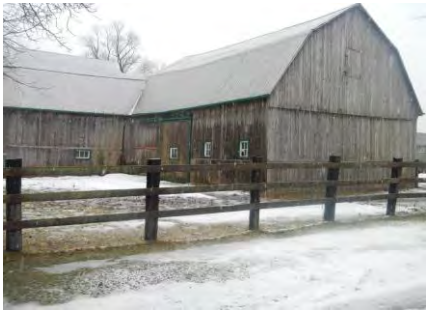
| Cultural Heritage Resource Number | Property | O.Reg. 9/06 Criteria | Justification | Rating | Thumbnail (full-size photos in Appendix A) |
|---|---|---|---|---|---|
| CHR-114 | 214 Gore A Road | Design or Physical | The wooden vertical board barn is constructed on an "L" shape plan, with a gambrel roof. | meets criteria | <p>Photo 115 - 118</p> |

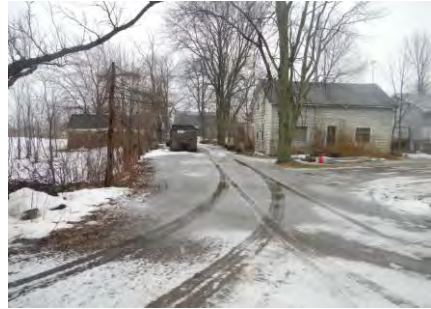
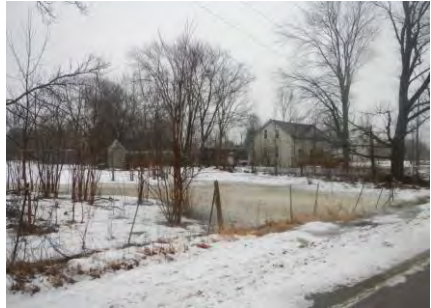
| Cultural Heritage Resource Number | Property | O.Reg. 9/06 Criteria | Justification | Rating | Thumbnail (full-size photos in Appendix A) |
|---|---|---|---|---|---|
| CHR-115 | 664 Marshagan Road | Design or Physical | One and a half storey gable-roofed cottage with wooden siding and original windows. An early example of simple cottage-style construction in area. Modern addition added to rear of cottage. | meets criteria | <br> <p>Photos 119 - 122</p> |

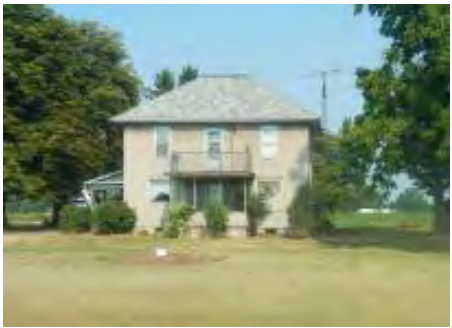
| Cultural Heritage Resource Number | Property | O.Reg. 9/06 Criteria | Justification | Rating | Thumbnail (full-size photos in Appendix A) |
|---|---|---|---|---|---|
| CHR-80 | 55 Moulton Aiken Road | Design or Physical | Two storey farmhouse on square footprint. Design features include: hipped roof with unique asphalt shingling; three bay front façade with second floor central door and balcony; entablature window trim; and stucco or plaster cladding. Rare use of plaster cladding in general area. | meets criteria | <p>Photo 103</p> |

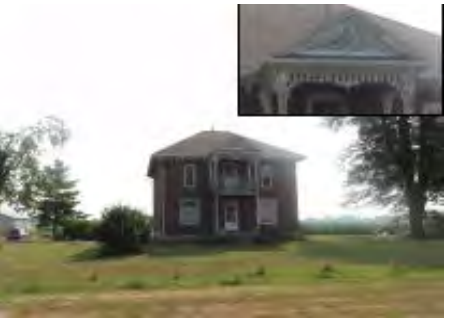
| Cultural Heritage Resource Number | Property | O.Reg. 9/06 Criteria | Justification | Rating | Thumbnail (full-size photos in Appendix A) |
|---|---|---|---|---|---|
| CHR-81 | 753 Inman Road | Design or Physical | Two storey brick farmhouse on square footprint. Design features include: a three bay front façade with central door and balcony on second floor; shaped window trim; and bracketed eaves. Balcony features Classically-inspired pediment with carved tympanum, decorated eaves and ornate capitals. Representative example of Edwardian Classicism-inspired vernacular, featuring rare and unique use of ornate balcony pediment. | meets criteria | <p>Photo 104</p> |

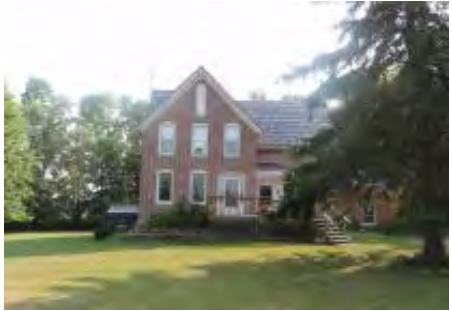
| Cultural Heritage Resource Number | Property | O.Reg. 9/06 Criteria | Justification | Rating | Thumbnail (full-size photos in Appendix A) |
|---|---|---|---|---|---|
| CHR-82 | 928 Canal Bank Road | Design or Physical | Two storey ell-shaped brick farmhouse. Design features include: highly contrasting brick and mortarwork; decorated fascia; three bay front facade; offset front door with side and transom lights; and tall, narrow attic window. Rare and early example of Italianate-inspired design. | meets criteria | <p>Photo 105</p> |

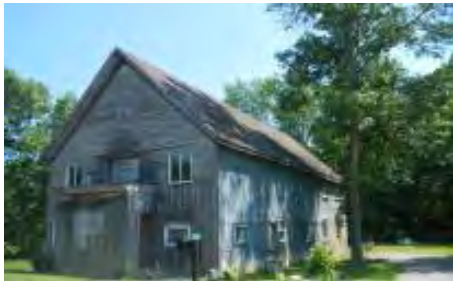
| Cultural Heritage Resource Number | Property | O.Reg. 9/06 Criteria | Justification | Rating | Thumbnail (full-size photos in Appendix A) |
|---|---|---|---|---|---|
| CHR-83 | 228 Feeder Canal Road | Design or Physical | Two storey gable roof building featuring horizontal wood siding on gable end, with board and batten. Design features include a round wooden attic ventilator, and addition of enclosed front entrance and windows. Currently a residence, but appears to be former warehouse. Early example of commercial building construction for the area. | meets criteria | <p>Photo 106</p> |
| | | Historical or Associative | Associated with the 19th century commercial activities of Stromness and the historic development of the Welland Feeder Canal. | | |
| | | Contextual | Contributes to the character of the area around Stromness as a 19th century commercial hub. | | |

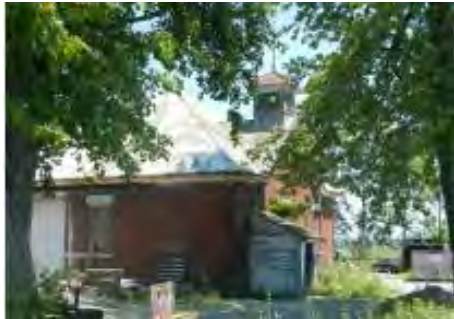
| Cultural Heritage Resource Number | Property | O.Reg. 9/06 Criteria | Justification | Rating | Thumbnail (full-size photos in Appendix A) |
|---|---|---|---|---|---|
| CHR-84 | Former Schoolhouse | Design or Physical | One storey hipped roof brick building. Features central triangular dormer with projecting bellfry and spire. Original structure heavily modified with introduction of new entrances and windows. Representative example of rural school institution. | meets criteria | <p>Photo 107</p> |

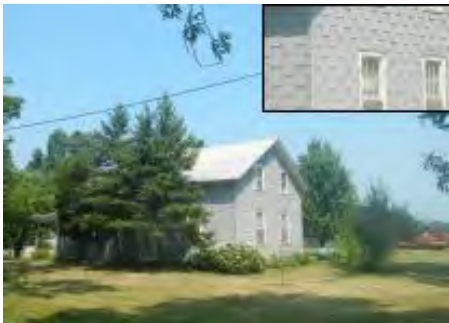
| Cultural Heritage Resource Number | Property | O.Reg. 9/06 Criteria | Justification | Rating | Thumbnail (full-size photos in Appendix A) |
|---|---|---|---|---|---|
| CHR-85 | 2307 North Shore Drive | Design or Physical | One and a half storey Gothic Revival cottage. Features three bay front façade, 3-over-2 hung windows with shaped trim, and tiled siding. Unique example of large, square, overlapping exterior shingle cladding. | meets criteria | <p>Photo 108</p> |

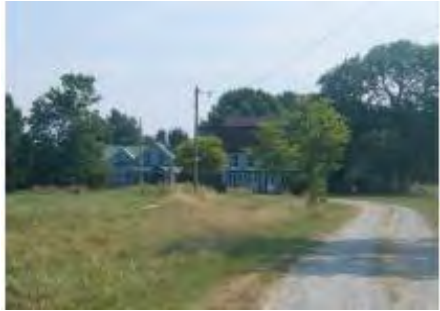
| Cultural Heritage Resource Number | Property | O.Reg. 9/06 Criteria | Justification | Rating | Thumbnail (full-size photos in Appendix A) |
|---|---|---|---|---|---|
| CHR-86 | 12698 Mittelstadt Road | Design or Physical | Farm complex at end of a long driveway includes two storey multiple-gabled house and two storey gambrel roof barn. House design features include: pedimented front porch; set of three windows in front gable; shaped window trim; and board and batten siding. Associated barn appears to be adapted for residential use and features: extended covered front entryway with central door; large 2-over-2 windows with curved pediments; and board and batten siding. There is sufficient potential for it to possess design value to warrant its exclusion as a built heritage resource. | cannot be excluded | <p>Photo 109</p> |

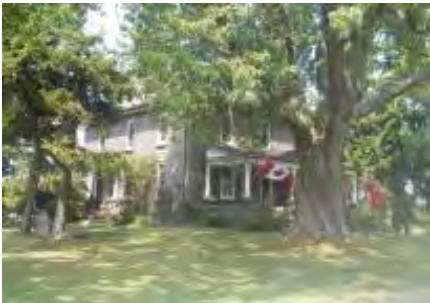
| Cultural Heritage Resource Number | Property | O.Reg. 9/06 Criteria | Justification | Rating | Thumbnail (full-size photos in Appendix A) |
|---|---|---|---|---|---|
| CHR-87 | 12822 Minor Road | Design or Physical | Two storey farmhouse on square footprint with faux stone cladding. Design features include large, pedimented front porch with columns set on fieldstone base and supports. Rare example of faux stone cladding and dominant fieldstone and column porch on farmhouse in the area. | meets criteria | <p>Photo 110</p> |
| | | Historical or Associative | No known associations which satisfy criterion 2, O.Reg.9/06. | | |
| | | Contextual | Consistent with the character of the surrounding landscape. | | |

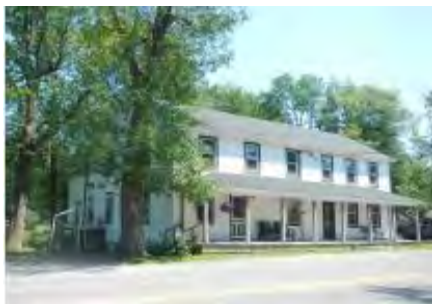
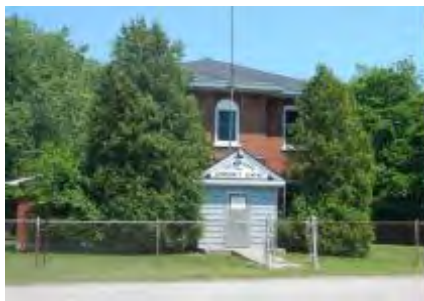
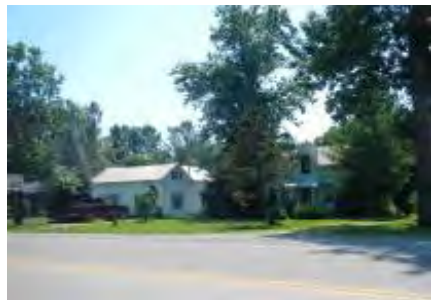
| Cultural Heritage Resource Number | Property | O.Reg. 9/06 Criteria | Justification | Rating | Thumbnail (full-size photos in Appendix A) |
|---|---|---|---|---|---|
| CHR-88 | Stromness Streetscape Cultural Heritage Landscape | Design or Physical | CHL 17 is a streetscape on the south side of the Welland Feeder Canal at the intersection of North Shore Road and Feeder Canal Road, where the canals from Dunnville and Port Maitland converge. Characterized by a mix of building design and types with narrow setbacks along North Shore Road, and extends approximately halfway to Rymer Road. While most buildings are residential, CHL also includes a two storey gable-roofed 19th century commercial building with front porch across front facade, and a large, two storey brick building with hipped roof (Sherbrooke Community Centre). | meets criteria | |
| | | Historical or Associative | Associated with the mid-19th century development of Stromness, originally known as Broad Creek, which was established during the construction of the Welland Feeder Canal. Streetscape is further associated with Lachlan McCallum, a Canadian MP and Senator, who settled in Stromness in 1855 and started several businesses there including a hotel, cheese factory and store, mills, and a shipbuilding business. Streetscape is also historically associated with a larger cultural heritage landscape, the Welland Feeder Canal, constructed 1832. | | |
| | | Contextual | Streetscape comprises an evolved cultural landscape. Although historical industrial and commercial activity has ceased, the streetscape continues to reflect the residential character of a small settlement. | | |

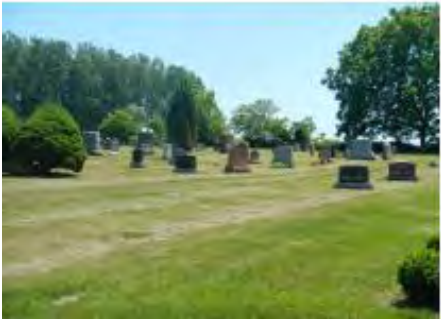
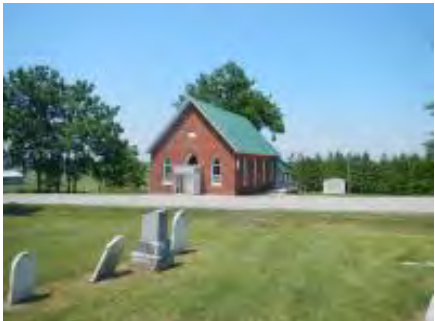
| Cultural Heritage Resource Number | Property | O.Reg. 9/06 Criteria | Justification | Rating | Thumbnail (full-size photos in Appendix A) |
|---|---|---|---|---|---|
| CHR-89 | Sherbrooke Baptist Church and Highbanks Cemetery Cultural Heritage Landscape | Design or Physical | CHL 18 straddles North Shore Drive, with the church on the north side and cemetery on the south. Established in 1842, the one storey gable roof brick church features: one storey addition to rear; labelstone; four bay side elevation; three bay front façade; central door with pointed transom and tracery, and projecting front entryway. Cross hung windows feature pointed heads with Y tracery. Cemetery boundary is clearly delineated by line of trees and bushes, and features headstones set on a generally open, gently sloping terrain. Representative example of rural religious architecture. | meets criteria | |
| | | Contextual | A defined landscape whose design and construction is a distinct reflection of religious practice. Landmark. | | Photos 114 and 115 |

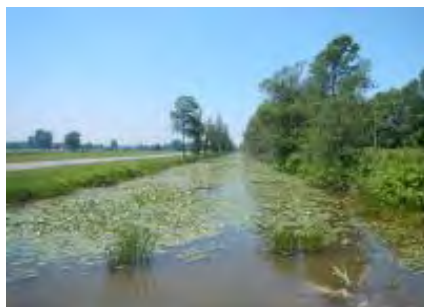
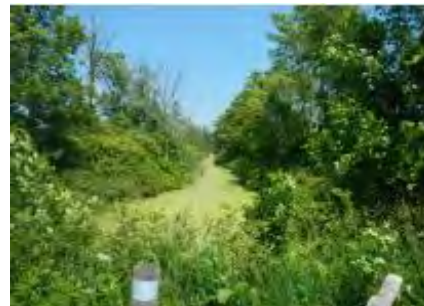
| Cultural Heritage Resource Number | Property | O.Reg. 9/06 Criteria | Justification | Rating | Thumbnail (full-size photos in Appendix A) |
|---|---|---|---|---|---|
| CHR-90 | Welland Feeder Canal Cultural Heritage Landscape | Design or Physical | Constructed in conjunction with the first Welland Canal beginning in 1829, the Welland Feeder Canal CHL is a 40 kilometer waterway built to convey water from the Grand River at Dunville to the Welland Canal. It was later enlarged to function as a shipping channel, and an additional terminus at Port Maitland was constructed, merging with the canal at Stromness. No longer in use, the Welland Feeder Canal features an excavated waterway with roads running along either side, now generally overgrown with vegetation. Parts of the canal have been filled in to allow for the construction of roads. The Feeder Canal extends beyond the boundaries of the Study Area to terminate at Dunnville and Port Maitland to the southwest, and at Welland to the northeast. | meets criteria | |
| | | Historical or Associative | The Feeder Canal is associated with the construction of the Welland canal system as part of the 19th century development of the Great Lakes transportation system. The Feeder Canal is further associated with the establishment and growth of several settlements and heritage properties along the Feeder Canal, including the Stromness Streetscape CHL. | | |
| | | Contextual | As a manmade engineering work, the Feeder Canal constitutes a clearly defined linear landscape. | | Photos 116-118 |

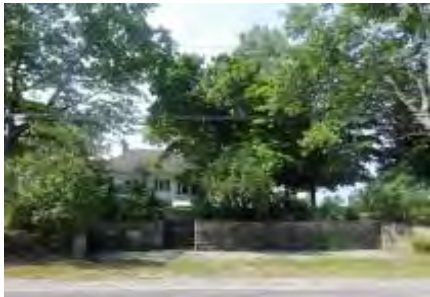
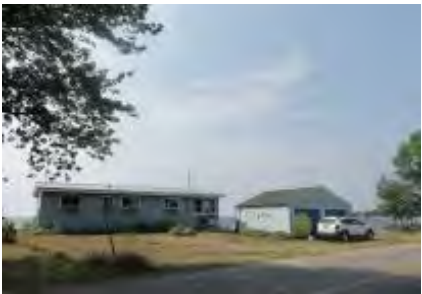
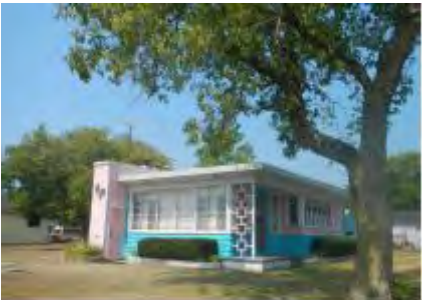
| Cultural Heritage Resource Number | Property | O.Reg. 9/06 Criteria | Justification | Rating | Thumbnail (full-size photos in Appendix A) |
|---|---|---|---|---|---|
| CHR-91 | Lowbanks Streetscape Cultural Heritage Landscape | Design or Physical | Lowbanks is one of the oldest settlements in Moulton Township, having been founded in 1772 by Lawrence Furry from Pennsylvania. Settlement was named Lowbanks with the establishment of a post office in 1865 and refers to the lowlying shoreline of the area, as compared to the higher banks in Sherbrooke Township. Streetscape is located on the shore of Lake Erie and extends along Lakeshore Road, from North Shore Drive to beyond the Study Area boundaries. Area has been increasingly used as a summer cottage and tourist destination, which is primarily reflected in the lowscale character and narrow lots of properties on both sides of the road. Cottages reflect a mix of design and construction dates (many appear to have been built in the early 20th century), and are generally of simple design, and one to two stories in height. Streetscape features beach stone retaining walls and significant vegetation along varying terrain. Institutions include: some tourist-related businesses; the contemporary Lowbanks Community Centre; several churches (Lowbanks Community of Christ and Bethel United Reform Church); and the Lowbanks Cemetery, located on the southern side of the road on the shoreline. the Lowbanks Streetscape also features more substantial buildings associated with the historic settlement and agricultural development of area, including the two storey wood Furry Tavern (a designated property, built 1821) and the two storey brick Moses Minor Century Farm. | meets criteria | |

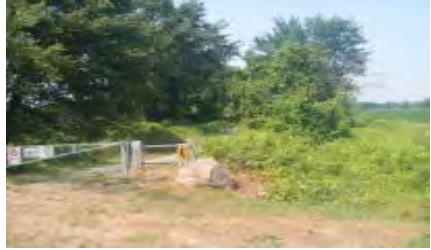
| Cultural Heritage Resource Number | Property | O.Reg. 9/06 Criteria | Justification | Rating | Thumbnail (full-size photos in Appendix A) |
|---|---|---|---|---|---|
| CHR-92 | Gord Harry Trail Cultural Heritage Landscape | Design or Physical | Former rail line converted into trail system. Features include: flat, gravel or dirt pathway; gated entrances where trail crosses roadways; and thick vegetation cover from trees and bushes along each side of the trail. Not a rare, unique, early or representative example of a particular style, use of materials or method of construction. Does not demonstrate an unusually high degree of craftsmanship, artistic merit or scientific achievement. | meets criteria | |
| | | Historical or Associative | A linear cultural landscape, the trail is associated with the former Buffalo and Lake Huron (Grand Trunk) Railroad and historical themes of local economic development, nation-building, and transportation. | | |
| | | Contextual | As a transportation corridor which has been in use since the mid-19th century, the Gord Harry Trail is functionally and historically linked to its surroundings. | | |

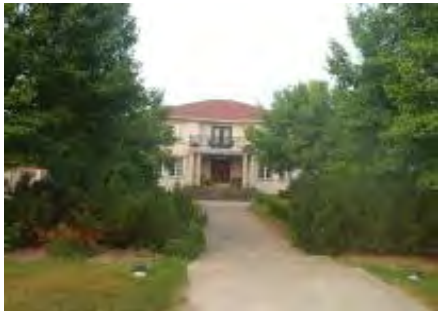
| Cultural Heritage Resource Number | Property | O.Reg. 9/06 Criteria | Justification | Rating | Thumbnail (full-size photos in Appendix A) |
|---|---|---|---|---|---|
| CHR-93 | 564 Kemp Road | Design or Physical | The Villa Bacchus bed and breakfast, built in 1976 as the former residence of the Comisso family. Character-defining features include the large, two storey estate house and the manicured gardens in its immediate setting which contribute to its Italian Villa design. | meets criteria | <p>Photo 149</p> |

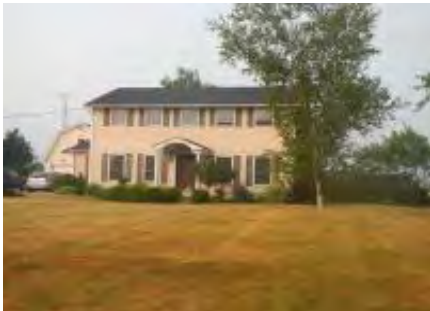
| Cultural Heritage Resource Number | Property | O.Reg. 9/06 Criteria | Justification | Rating | Thumbnail (full-size photos in Appendix A) |
|---|---|---|---|---|---|
| CHR-94 | 592 Kemp Road | Design or Physical | Two storey gable-roofed house. Design features include five bay front façade with central portico and wide doorway, suggesting Georgian design. Representative example of Georgian-influenced architecture. | meets criteria | <p>Photo 150</p> |

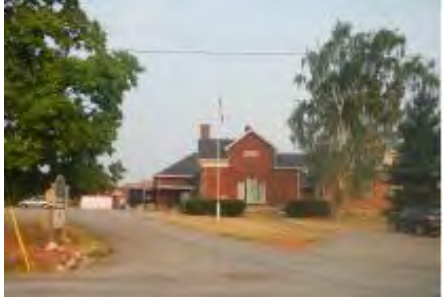
| Cultural Heritage Resource Number | Property | O.Reg. 9/06 Criteria | Justification | Rating | Thumbnail (full-size photos in Appendix A) |
|---|---|---|---|---|---|
| CHR-95 | 4516 Mountainview Road | Design or Physical | Niagara Presents Specialty Foods store and processing plant. Multiple-gabled brick building appears to incorporate former schoolhouse. Design elements include: brickwork detailing around eaves, gable, and windows of front elevation; and labelstone which reads "School Section No. 2 Clinton 1902". School facade a unique example in area of early 20th century rural schoolhouse design. | meets criteria | <p>Photo 151</p> |

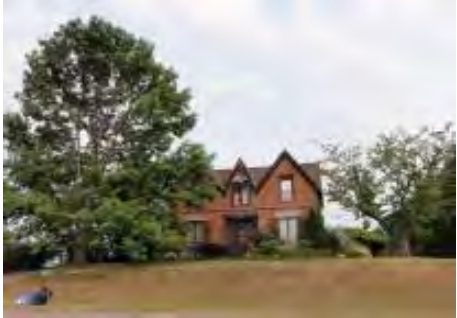
| Cultural Heritage Resource Number | Property | O.Reg. 9/06 Criteria | Justification | Rating | Thumbnail (full-size photos in Appendix A) |
|---|---|---|---|---|---|
| CHR-96 | 252 Thirty Road | Design or Physical | Large, one and a half storey Gothic Revival brick house. Design features include: finials and gable bargeboard bargeboarding; prominent central doorway with side and transom lights; and a biforate rounded lancet window. A unique and representative example of Gothic Revival vernacular design with three front gables. | meets criteria | <p>Photo 152</p> |

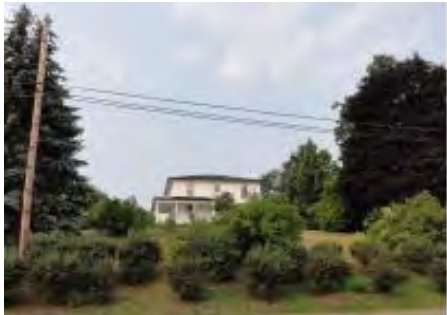
| Cultural Heritage Resource Number | Property | O.Reg. 9/06 Criteria | Justification | Rating | Thumbnail (full-size photos in Appendix A) |
|---|---|---|---|---|---|
| CHR-97 | 5432 King Street | Design or Physical | Two storey hipped roof farmhouse on a square footprint. Design features include: three bay front façade with central first and second storey doors and 3-over-2 hung windows; wraparound porch; chimneys on opposing exterior walls; and plaster cladding. Rare use of plaster exterior cladding in area. | meets criteria | <p>Photo 153</p> |

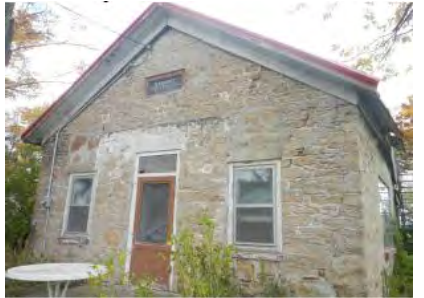
| Cultural Heritage Resource Number | Property | O.Reg. 9/06 Criteria | Justification | Rating | Thumbnail (full-size photos in Appendix A) |
|---|---|---|---|---|---|
| CHR-98 | 3263 South Grimsby Road 3 | Design or Physical | Former Grimsby Union school Section 7, built 1865. Currently being converted into residence. One storey stone building with gabled roof and small, one storey rear addition, set among mature deciduous trees on a small rise. Design features include: three bay front facade with central doorway; original wood frame windows and wood label plate on front facade; and a simple cornice. | meets criteria | |
| | | Historical or Associative | Associated with the development and education of the local community. | | |
| | | Contextual | Quintessential one room schoolhouse defines and is historically linked to the rural landscape. Functions as a landmark. | | |

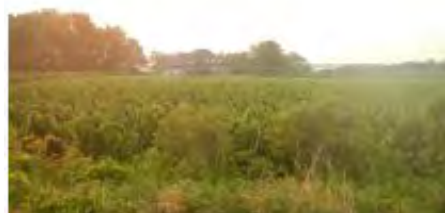
| Cultural Heritage Resource Number | Property | O.Reg. 9/06 Criteria | Justification | Rating | Thumbnail (full-size photos in Appendix A) |
|---|---|---|---|---|---|
| CHR-99 | Organized Crime Winery CHL (4043 Mountainview Road) | Design or Physical | Organized Crime Winery (4043 Mountainview Road) includes one and a half storey modern residence and wine bar and associated vineyards. Landscape characterized by the rolling terrain of the Niagara Escarpment, and is located in the Beamsville Bench wine-growing sub-appellation. | meets criteria | |
| | | Historical or Associative | Associated with the development of the wine-making and other fruit-growing industries in the Niagara area, one of the oldest and largest wine-growing regions in Canada. | | |
| | | Contextual | As an evolved landscape, CHL 22 demonstrates a unique relationship between the natural environment and the socio-economic practices associated with wine-growing through its cultivated vineyards. Supports character of the area as a wine-making and fruit-growing region. | | |

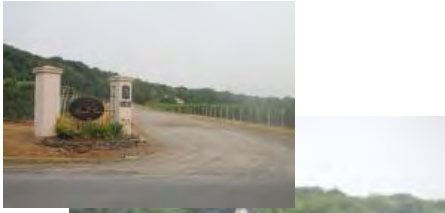
| Cultural Heritage Resource Number | Property | O.Reg. 9/06 Criteria | Justification | Rating | Thumbnail (full-size photos in Appendix A) |
|---|---|---|---|---|---|
| CHR-100 | Angels Gate Winery CHL (4260 and 4262 Mountainview Road) | Design or Physical | Angels Gate Winery CHL (4260 and 4262 Mountainview Road) includes one storey gabled-roof residence, large Italian Villa-inspired winery estate house and associated vineyards. Landscape characterized by the rolling terrain of the Niagara Escarpment, and is located in the Beamsville Bench wine-growing sub-appellation. | meets criteria | |
| | | Historical or Associative | Associated with the development of the wine-making and other fruit-growing industries in the Niagara area, one of the oldest and largest wine-growing regions in Canada. | | |
| | | Contextual | As an evolved landscape, CHL 23 demonstrates a unique relationship between the natural environment and the socio-economic practices associated with wine-growing through its cultivated vineyards. Supports character of the area as a wine-making region. | | |

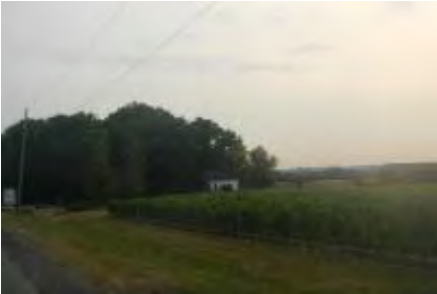
| Cultural Heritage Resource Number | Property | O.Reg. 9/06 Criteria | Justification | Rating | Thumbnail (full-size photos in Appendix A) |
|---|---|---|---|---|---|
| CHR-101 | Thirty Bench Winemakers CHL (4281 Mountainview Road) | Design or Physical | Thirty Bench Winemakers CHL (4281 Mountainview Road) includes one storey cottage and large, one storey gable-roofed winery estate house, and associated vineyards. Landscape characterized by the rolling terrain of the Niagara Escarpment, and is located in the Beamsville Bench wine-growing sub-appellation. | meets criteria | |
| | | Historical or Associative | Associated with the development of the wine-making and other fruit-growing industries in the Niagara area, one of the oldest and largest wine-growing regions in Canada. | | |
| | | Contextual | As an evolved landscape, CHL 24 demonstrates a unique relationship between the natural environment and the socio-economic practices associated with wine-growing through its cultivated vineyards. Supports character of the area as a wine-making and fruit-growing region. | | |

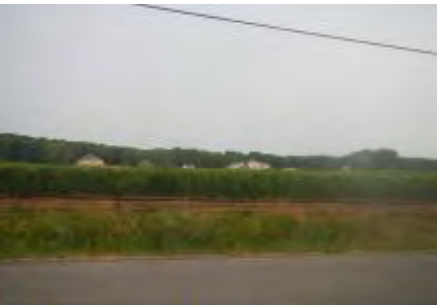
| Cultural Heritage Resource Number | Property | O.Reg. 9/06 Criteria | Justification | Rating | Thumbnail (full-size photos in Appendix A) |
|---|---|---|---|---|---|
| CHR-102 | Rosewood Estates CHL (4352 Mountainview Road) | Design or Physical | Rosewood Estates (4352 Mountainview Road) includes several buildings which form an estate, and associated vineyards. Landscape characterized by the rolling terrain of the Niagara Escarpment, and is located in the Beamsville Bench wine-growing sub-appellation. | meets criteria | |

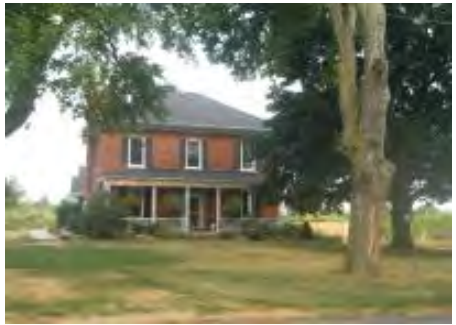
| Cultural Heritage Resource Number | Property | O.Reg. 9/06 Criteria | Justification | Rating | Thumbnail (full-size photos in Appendix A) |
|---|---|---|---|---|---|
| CHR-103 | 4560 Mountainview Road CHL | Design or Physical | Agricultural CHL includes two storey hipped-roof brick farmhouse and associated orchards. Landscape characterized by the flat terrain of the Lincoln Lakeshore sub appellation and the glacial Lake Iroquois Plain, a distinctive micro-climate in the Niagara Region, located between the Escarpment and Lake Ontario. | meets criteria | <p>Photo 160</p> |

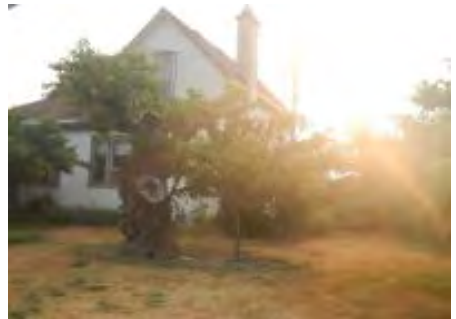
| Cultural Heritage Resource Number | Property | O.Reg. 9/06 Criteria | Justification | Rating | Thumbnail (full-size photos in Appendix A) |
|---|---|---|---|---|---|
| CHR-104 | 4649 Mountainview Road CHL | Design or Physical | Agricultural landscape includes one and a half storey multiple-gabled farmhouse with plaster cladding, an outbuilding and associated orchards. Landscape characterized by the flat terrain of the Lincoln Lakeshore sub appellation and the glacial Lake Iroquois Plain, a distinctive micro-climate in the Niagara Region, located between the Escarpment and Lake Ontario. | meets criteria | <p>Photo 161</p> |

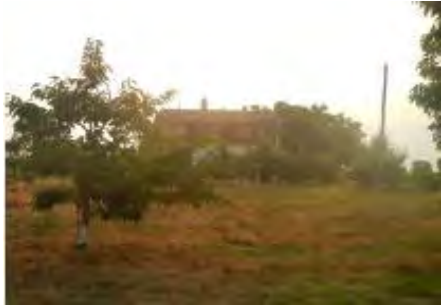
| Cultural Heritage Resource Number | Property | O.Reg. 9/06 Criteria | Justification | Rating | Thumbnail (full-size photos in Appendix A) |
|---|---|---|---|---|---|
| CHR-105 | 4673 Mountainview Road CHL | Design or Physical | Agricultural landscape includes one and a half storey gambrel-roofed vernacular house and associated orchards. Landscape characterized by the flat terrain of the Lincoln Lakeshore sub-appellation and the glacial Lake Iroquois Plain, a distinctive micro-climate in the Niagara Region, located between the Escarpment and Lake Ontario. | meets criteria | <p>Photo 162</p> |

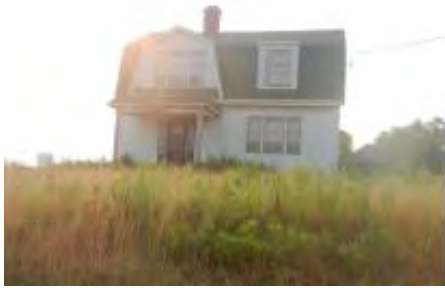
| Cultural Heritage Resource Number | Property | O.Reg. 9/06 Criteria | Justification | Rating | Thumbnail (full-size photos in Appendix A) |
|---|---|---|---|---|---|
| CHR-106 | 4717 Mountainview Road CHL | Design or Physical | Agricultural landscape includes: one and a half storey cross-gambrel roof house; a one and a half store ell-shaped vernacular farmhouse; various outbuildings; and associated orchards. Landscape characterized by the flat terrain of the Lincoln Lakeshore sub-appellation and the glacial Lake Iroquois Plain, a distinctive micro-climate in the Niagara Region, located between the Escarpment and Lake Ontario. | meets criteria | <p>Photo 163</p> |
| | | Historical or Associative | Associated with the development of the wine-making and other fruit-growing industries in the Niagara area, one of the oldest and largest wine-growing regions in Canada. | | |
| | | Contextual | As an evolved landscape, 4717 Mountainview Road demonstrates a unique relationship between the natural environment and the socio-economic practices associated with fruit-growing through its cultivated orchards. Supports character of the area as a wine-making and fruit-growing region. | | |

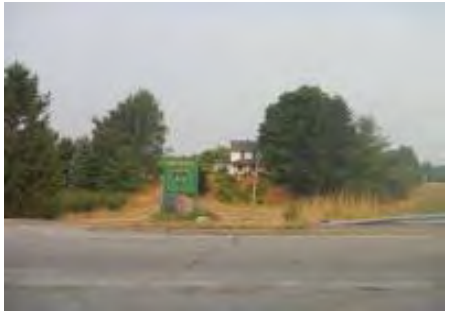
| Cultural Heritage Resource Number | Property | O.Reg. 9/06 Criteria | Justification | Rating | Thumbnail (full-size photos in Appendix A) |
|---|---|---|---|---|---|
| CHR-107 | Andrewes Farm Limited CHL (4764 Mountainview Road) | Design or Physical | Agricultural landscape consists of a primarily fruit-producing 625 acre farm. Landscape characterized by the flat terrain of the Lincoln Lakeshore sub-appellation and the glacial Lake Iroquois Plain, a distinctive micro-climate in the Niagara Region, located between the Escarpment and Lake Ontario. | meets criteria | <p>Photo 164</p> |

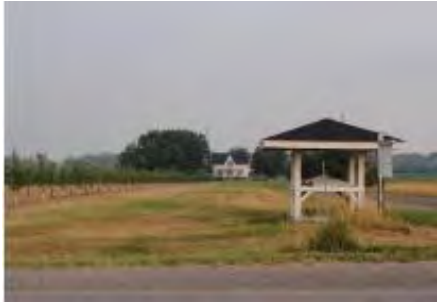
| Cultural Heritage Resource Number | Property | O.Reg. 9/06 Criteria | Justification | Rating | Thumbnail (full-size photos in Appendix A) |
|---|---|---|---|---|---|
| CHR-108 | 324 Thirty Road CHL | Design or Physical | CHL includes one and a half storey plaster cladded Gothic Revival cottage and associated vineyards. Landscape characterized by the rolling terrain of the Niagara escarpment, and is located in the Vinemount Ridge wine-growing sub-appellation. | meets criteria | <p>Photo 165</p> |

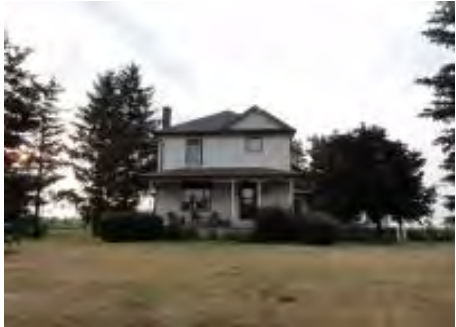
| Cultural Heritage Resource Number | Property | O.Reg. 9/06 Criteria | Justification | Rating | Thumbnail (full-size photos in Appendix A) |
|---|---|---|---|---|---|
| CHR-109 | 305 Thirty Road<br>CHL | Design or Physical | CHL 32 includes two storey vernacular farmhouse and associated orchards and vineyards. Landscape characterized by the rolling terrain of the Niagara Escarpment, and is located in the Vinemount Ridge wine-growing sub-appellation. | meets<br>criteria | <p>Photo 166</p> |

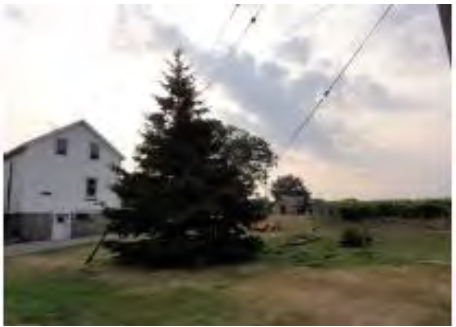
| Cultural Heritage Resource Number | Property | O.Reg. 9/06 Criteria | Justification | Rating | Thumbnail (full-size photos in Appendix A) |
|---|---|---|---|---|---|
| CHR-110 | 4367 Thirty Road<br>CHL | Design or Physical | CHL 33 includes two storey vernacular farmhouse, agricultural outbuildings including a one storey gabled stone shed and associated vineyards. Landscape characterized by the rolling terrain of the Niagara Escarpment, and is located in the Beamsville Bench wine-growing sub-appellation. | meets<br>criteria | <p>Photo 167</p> |

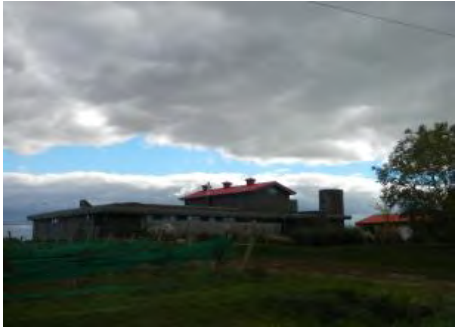
| Cultural Heritage Resource Number | Property | O.Reg. 9/06 Criteria | Justification | Rating | Thumbnail (full-size photos in Appendix A) |
|---|---|---|---|---|---|
| CHR-111 | Aure Wines (3749 Walker Road) | Design or Physical | Cultural heritage landscape. Aure Winery is a small winery which has been in operation since 2007. The landscapes include a small vineyard, the remains of a concrete silo and stone foundation building, and several barns and other buildings associated with wine production. Landscape characterized by the gently rolling terrain of the Niagara Escarpment, and is located in the Vinemount Ridge wine-growing sub-appellation. | meets criteria | <p>Photo 168</p> |
