Niagara Region Wind Corporation  
Niagara Region Wind Farm

**Heritage Resources & Project Components  
Area 4**

Table 8: Evaluation of Cultural Heritage Resources and Landscapes, Area 4

Table 19: Summary of Potential Negative Impacts and Recommended Mitigation

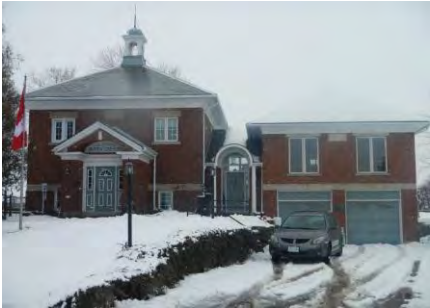
| Cultural Heritage Resource Number | Property | O.Reg. 9/06 Criteria | Justification | Rating | Thumbnail (full-size photos in Appendix A) |
|---|---|---|---|---|---|
| CHR-116 | 498 Elm Tree Road East | Design or Physical | The two storey brick building is a former schoolhouse or church, now converted into a residence. The building consists of a main structure, constructed on a rectangular plan with a hipped roof, and a two storey square addition with a hipped roof. Value defining features include a rounded bell tower; a front door with sidelights and a returned eave portico; and stone banding, sills, and lintels | meets criteria | <p>Photo 169</p> |

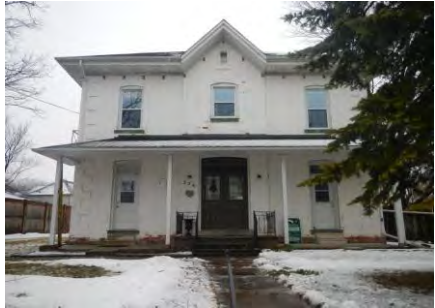
| Cultural Heritage Resource Number | Property | O.Reg. 9/06 Criteria | Justification | Rating | Thumbnail (full-size photos in Appendix A) |
|---|---|---|---|---|---|
| CHR-117 | 276 Main Street East | Design or Physical | The property includes a two storey building on a square plan, with a hipped roof, large front porch, and frontispiece | meets criteria | <p>Photo 170</p> |

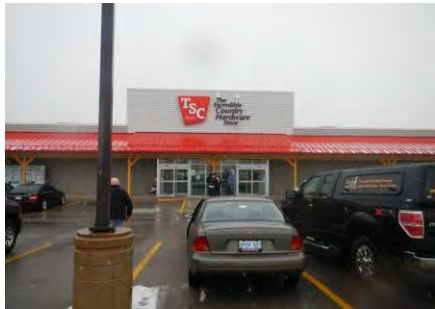
| Cultural Heritage Resource Number | Property | O.Reg. 9/06 Criteria | Justification | Rating | Thumbnail (full-size photos in Appendix A) |
|---|---|---|---|---|---|
| CHR-118 | 321 Main Street East | Design or Physical | This property appears to have recently been replaced with a TSC Store. | meets criteria | <p>Photo 171</p> |

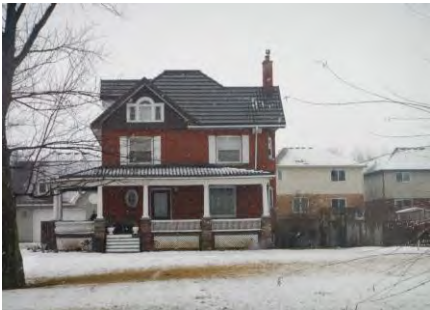
| Cultural Heritage Resource Number | Property | O.Reg. 9/06 Criteria | Justification | Rating | Thumbnail (full-size photos in Appendix A) |
|---|---|---|---|---|---|
| CHR-119 | 326 Main Street East | Design or Physical | The property features a two storey brick building on a wide setback. Value defining features include an irregular, multiple-gabled roof, attic window with rounded transom and sidelights, and a large, wraparound porch. | meets criteria | |
