Project: Niagara Region Wind Farm

Report Title: Heritage Assessment

Applicant: Niagara Region Wind Corporation

FINAL REPORT Heritage Assessment, Niagara Region Wind Farm

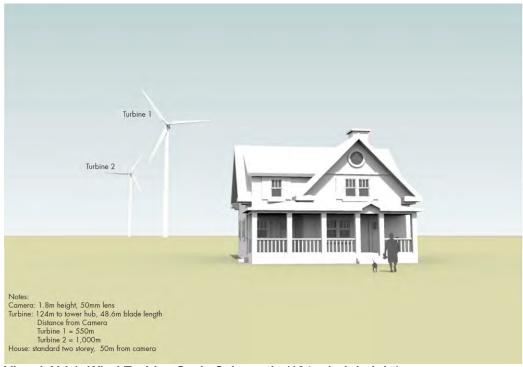
Visual Aid 1: Wind Turbine Scale Schematic (124m hub height)

The hub height of the proposed wind turbines will be either 124 m or 135 m with a blade length of 48.5 m. In order to evaluate the potential visual impact of turbines, general topographical conditions and land-use recorded during the site visit, aerial imagery, and comparative examples from similar projects were reviewed. Visual modelling was also used to inform the evaluation with respect to assessing the scale of new turbines relative to existing built features. Visual Aid 1 presents the scale of a turbine with a 124 m hub height at a distance of 550 m and 1000 m from a typical two storey residential building. Visual Aid 2 presents that same model with trees at various locations and distances in order to evaluate the effectiveness of tree-cover as an effective mitigative measure. Visual Aids 3 and 4 present similar models with a hub height of 135 m.

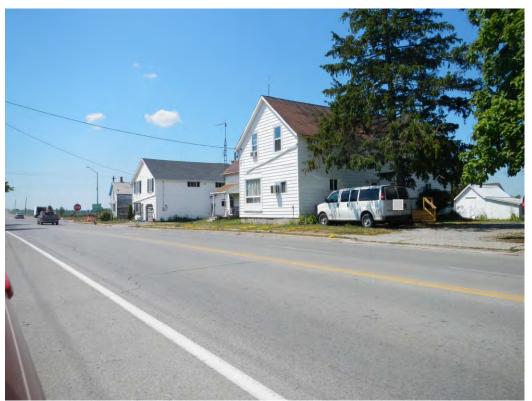
Plate 3: Example of narrowly setback residential building along major roads and near crossroads (Bismark)

residential and commercial buildings tend to be narrowly setback (Plate 3). At several of these same crossroads schoolhouses and religious buildings are still extant. Farm complexes within the Study Area range in size from small to very large and tend to be widely setback (Plates 4 and 5) although narrowly setback agricultural buildings are also found throughout the Study Area (Plate 6). Cultivated fields tend to be extensive and are interrupted by woodlots and tree lines (Plate 7).
