NIAGARA REGION WIND FARM DESIGN AND OPERATIONS REPORT

Property Line Setback Report

NIAGARA REGION WIND FARM PROPERTY LINE SETBACK ASSESSMENT REPORT

File No. 160950269 April 2013

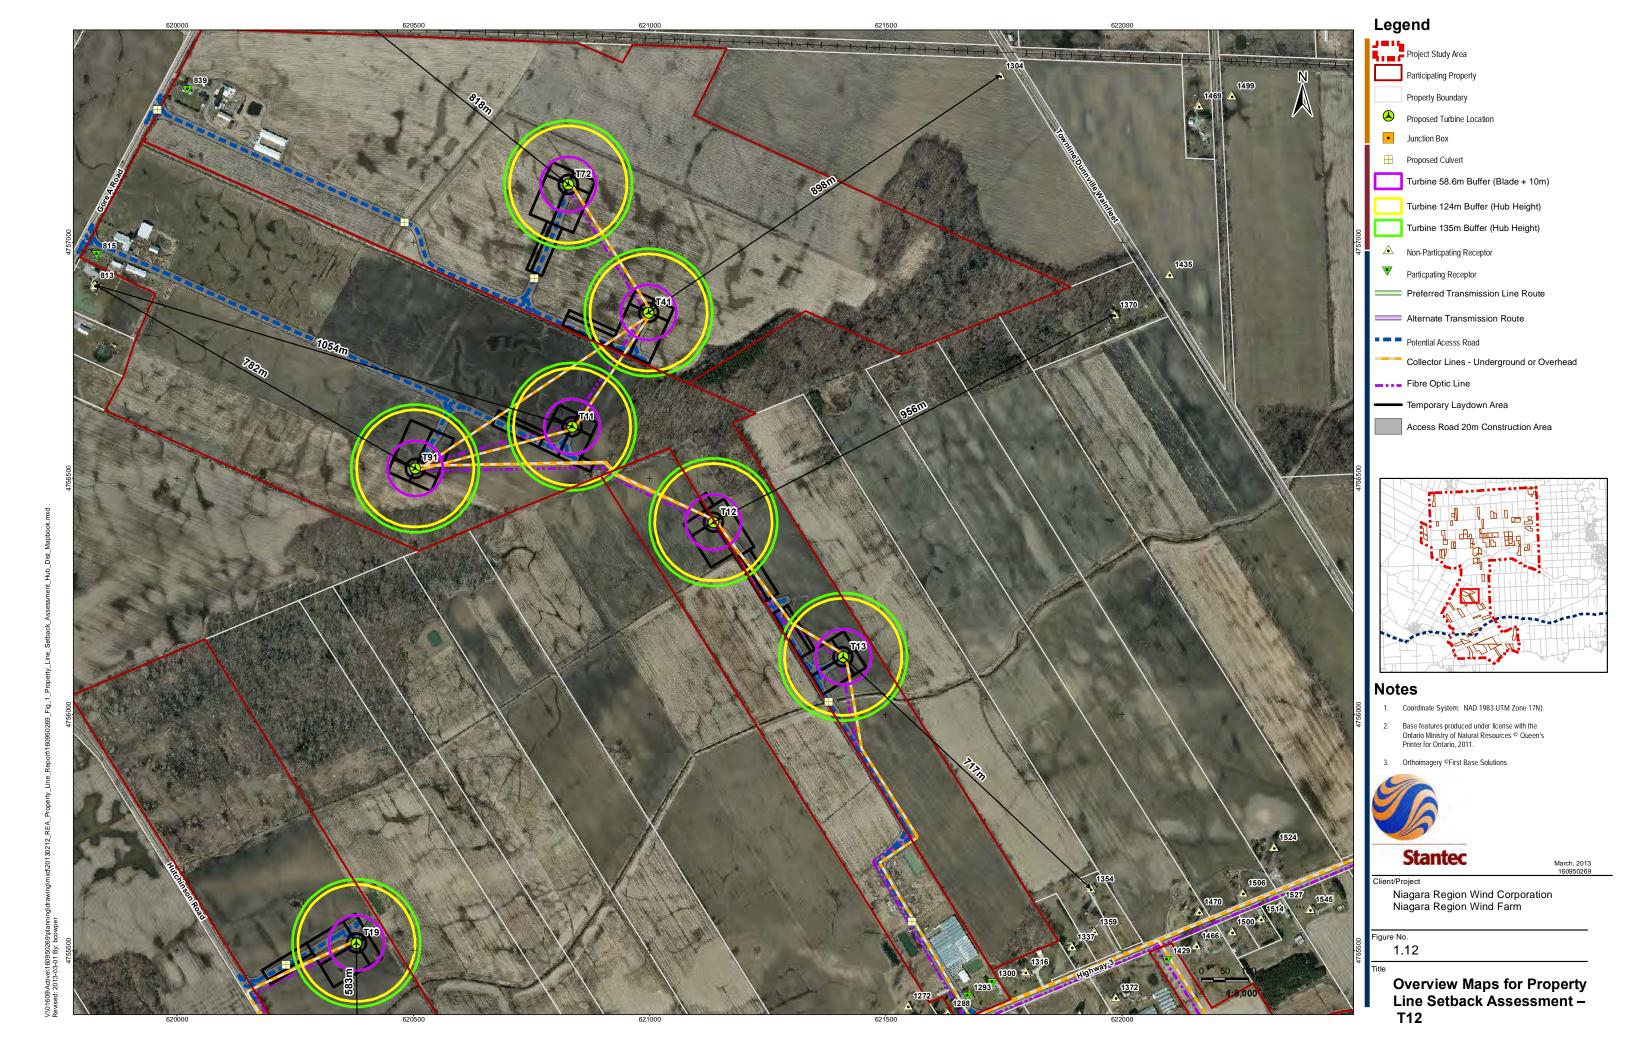
Inset Maps for Property Line Setback - T12

Project Study Area Participating Property Property Boundary Proposed Turbine Location Distance to Property Boundary Turbine 58.6m Buffer (Blade + 10m) Turbine 124m Buffer (Hub Height) Turbine 135m Buffer (Hub Height) Non-Particpating Receptor Participating Receptor

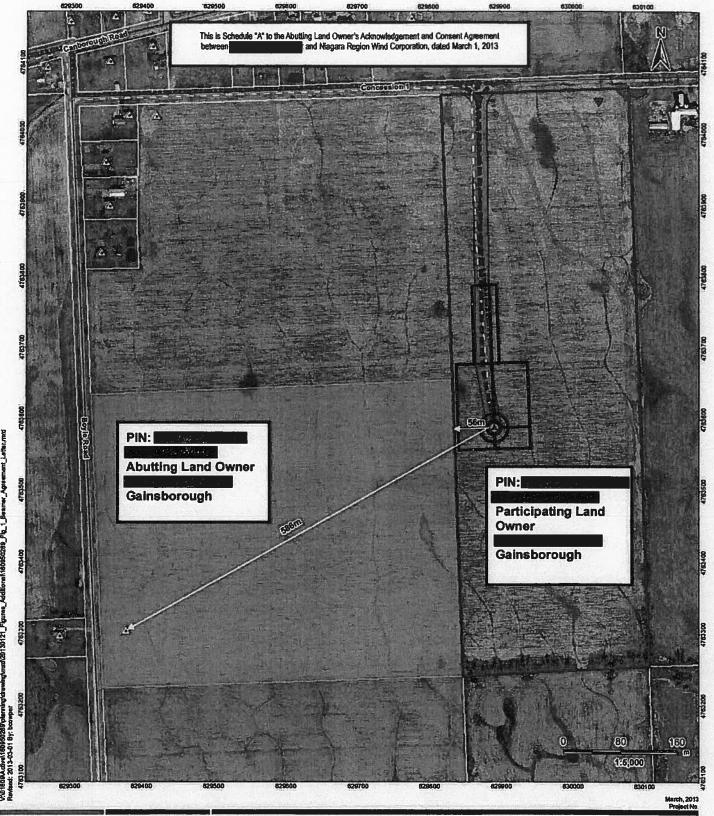
egend		Beamer Property Boundary	And the	Distance to Property Boundary
	(T) (II)	Participating Property		Potential Acesss Road
	1	Property Boundary		Collector Lines - Underground or Ov
		Proposed Turbine Location		Fibre Optic Line
	-	Participating Receptor		Road
