ASSESSMENT REPORT - **Project: 16227.00**

Niagara Region Wind Farm Project
Acoustic Immission Audit – Phase 1

19 July 2018

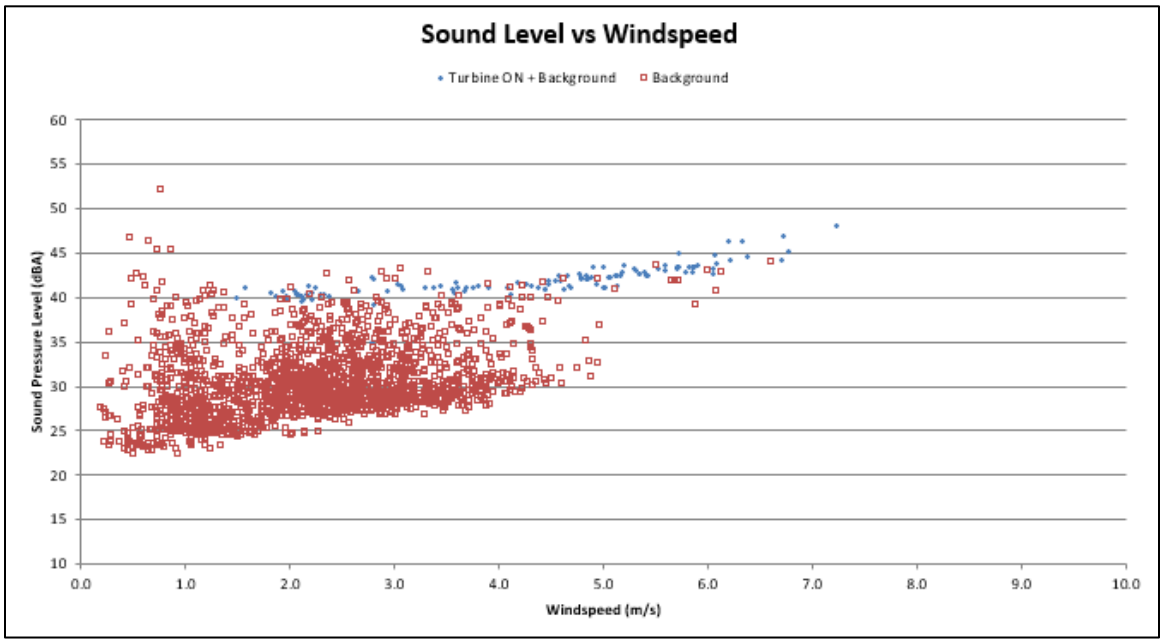
Figure 4: M0616 - Measured Sound Levels for Turbine ON and Background vs Wind Speed

Despite the extended duration (3 months) of the acoustic monitoring campaign the minimum reporting requirements (as per Part E5.5 of the protocol) has not been fulfilled at receptor measurement locations O_616. Acoustic measurements at this location has been more challenging due to less prevalent downwind conditions during the audit period and contamination from extraneous sources (animal activity, road traffic) during downwind conditions and high electrical power output.

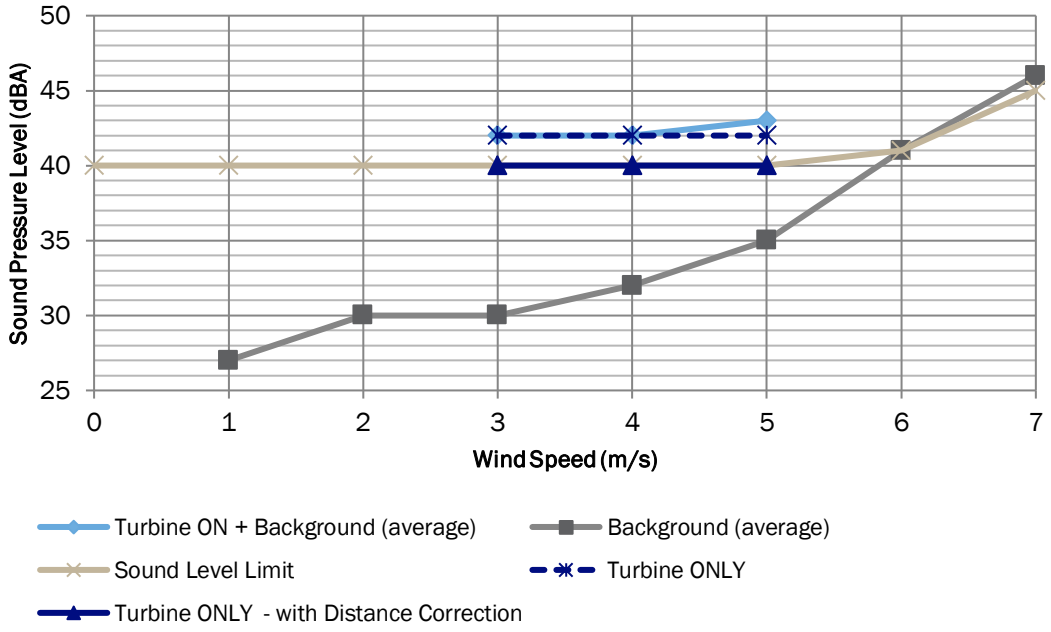
Figure 6: M1153 Turbine Levels compared to MOECP Limits

Based on the calculated turbine-only component indicated in Table 10 and Figures 6 to 9, the Niagara Region Wind Farm Project was found to be compliant with MOECP limits at receptors M1153, V2705, M1602 and M0085 during the audit.
